### 1.0 Problem Reported by Customer

### 3.0 Results of Inspection and Testing

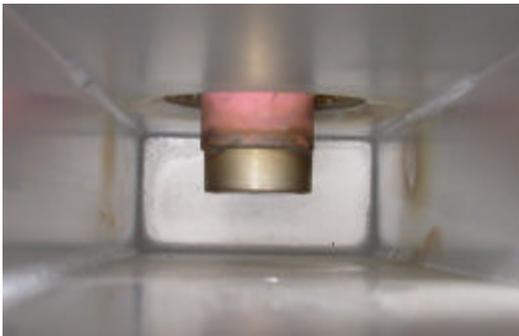
Photo 1

Evidence of arcing inside waveguide at the magnetron antenna (photo 1). Vacuum seal broken at antenna (photo 2). No evidence of arcing along the length of the waveguide.

Arcing between the antenna and waveguide can only be caused by an excessively high electric field at the magnetron antenna. The only possible causes are a high level of reverse power (high VSWR) or an arc that originated somewhere down the waveguide which would then have traveled to the magnetron antenna (arcing in waveguide always tends to travel toward the magnetron). Once established between the antenna and waveguide, arcing would have been sustained as long as microwave power was being generated.

Since there is no evidence of arcing along the length of the waveguide, our conclusion is that magnetron failure occurred due to high reverse power (high VSWR) at the magnetron antenna.

The microwave generator in which this magnetron was used should never be operated without the use of a 2-port waveguide isolator (or 3-port circulator and dummy load) to protect the magnetron from reverse power. Since a circulator and dummy load were delivered along with the generator, it is presumed these components were installed in a system configuration for magnetron protection as described in the respective product user manuals that were delivered with the equipment. However, it is possible that protection may have been compromised if water flow in the dummy load was not provided according to instructions. The use of a water flow interlock device can help prevent damage due to lack of water flow.

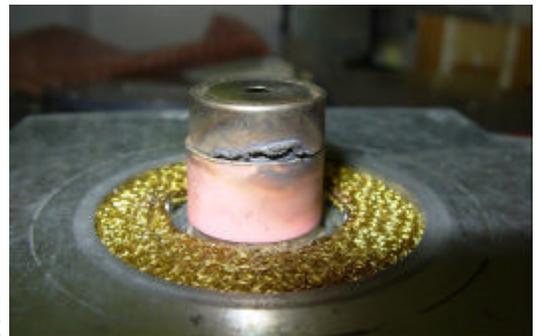
Photo 2

The sustained arcing eventually caused failure of the vacuum seal between the ceramic antenna body and metal cap. The sudden inrush of air (oxygen) inside the magnetron body while the filament and anode were at full operating temperature allowed rapid oxidation of the heated metal surfaces. Since the filament voltage was still being applied, the filament quickly overheated until melting and thus creating the open circuit.

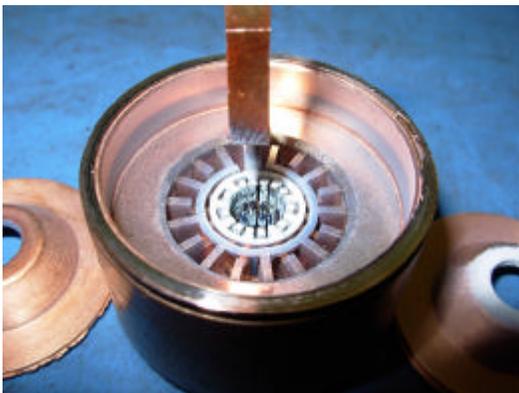
Photo 3

The magnetron was disassembled and internally inspected. Heavy oxidation was found on the anode vanes and straps (photos 3 and 4). No deformation of the anode or antenna structures was found.

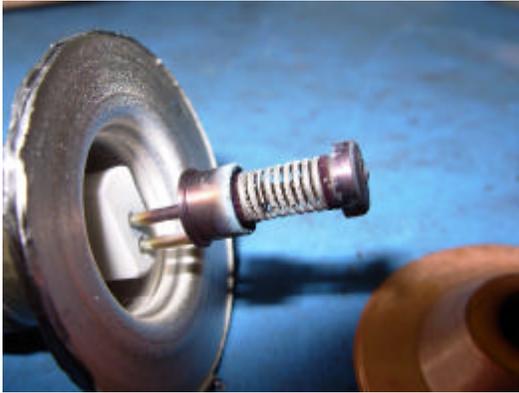
Photo 5

The magnetron filament resistance was measured and found to be infinite, thus indicating an open circuit. Resistance between the anode and either filament lead was also found to be infinite for both.

Heavy oxidation was also found on the filament, as well as evidence of the open filament wire (photo 5). The filament wire is otherwise fully intact and shows no other indication of deformation.
