### 1.0 Problem Reported by Customer

### 3.0 Results of Inspection and Testing

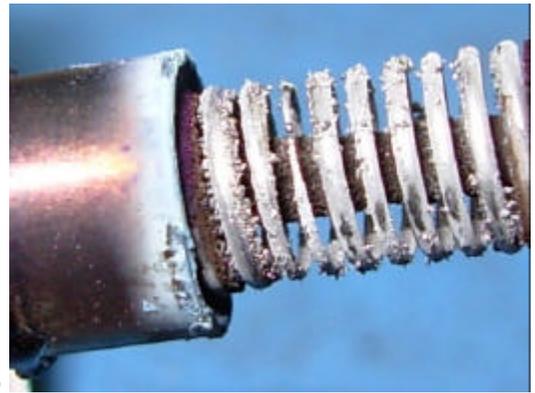
Photo 6

Heavy oxidation was also found on the filament, as well as evidence of the open filament wire (photo 5). The filament wire is otherwise fully intact and shows no other indication of deformation.
